RADC-TR-75-134  
Final Technical Report  
May 1975

THERMOMECHANICAL TESTING TECHNIQUES FOR MICROCIRCUITS

Motorola, Inc.

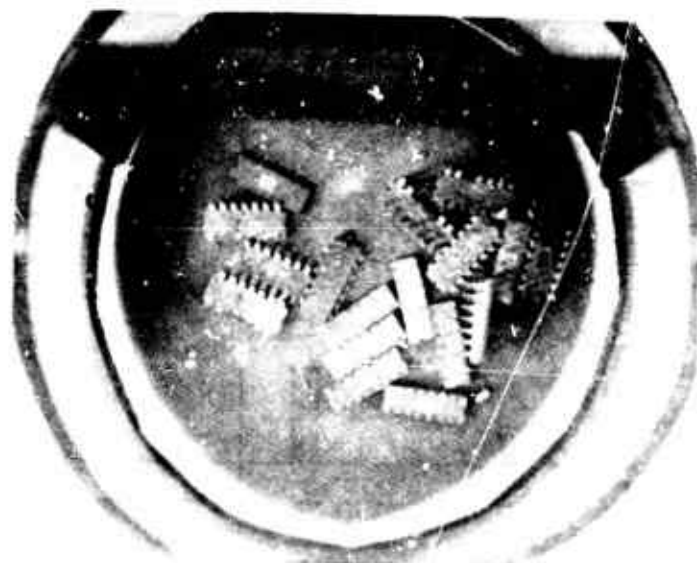
Figure 4-30. Vendor 9 Devices After 10 Cycles  
Thermal Shock Method 1010D  
(-65°C to 200°C)

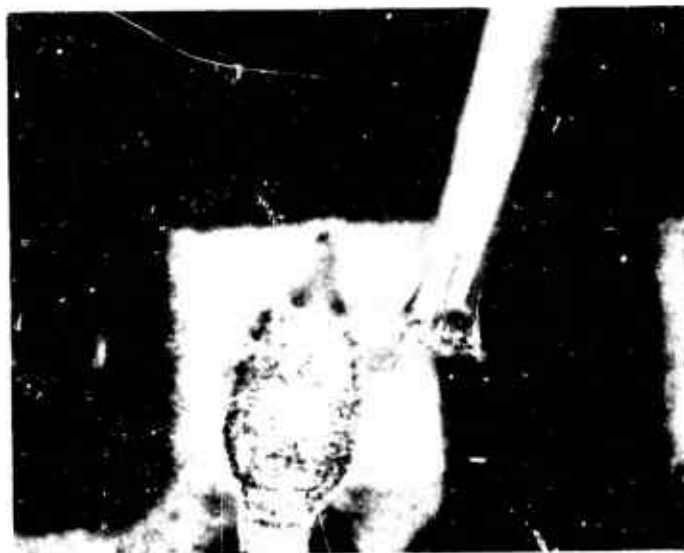
Figure 5-5. Wireflex Failure - Pad Bond  
(Lot D6, 4500 Cycles of 1010C)

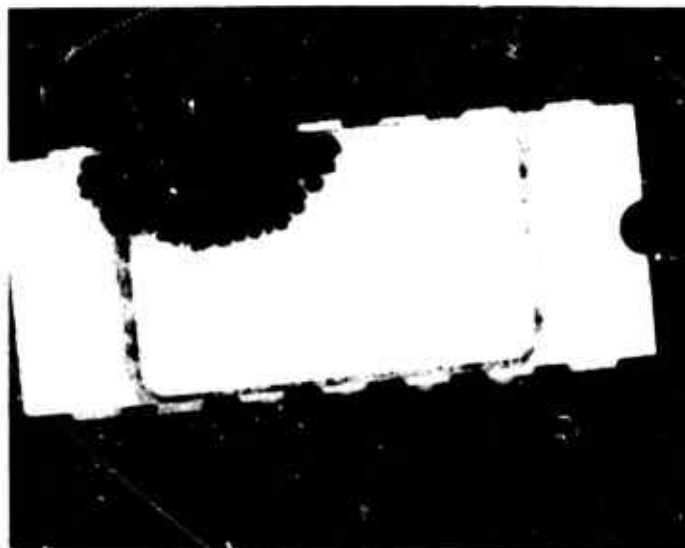
Figure 5-14. Gross Leak (Red Dye) at Cap Seal  
(Lot All, Sidebrazed, 10 Cycles of 1010E)

Several leak responses were noted. First ceramic devices subjected to thermal cycling would become fine leakers after some number of cycles. These devices, which passed gross leak but repeated as fine leakers, were left in the lot and given additional thermal cycling. At each subsequent readout, these same devices would fail fine leak until eventually they failed gross leak, were removed from the test and verified with red dye. All indications were that thermal cycling, especially thermal shock, Method 1011, caused micro-cracks to form between the bubbles on voids in the sealing glass material. Section 4.3 shows that the sealing glass is the weak material. As more and more micro-cracks were formed, more helium was trapped in the connected voids, increasing the measured leak value. After sufficient thermal cycling, the amount of micro-cracking became great enough to cause the trapping of enough fluorocarbon to cause a failure indication to this test. Red dye verification showed that the dye often penetrated only halfway to the cavity. The internal cavity was still hermetic but the device failed both fine and gross leak tests. This progressive deterioration in leak test performance correlates well with the torque test results of Section 4.9. The amount of micro-cracking seems to correspond to the decrease in mean torque value.

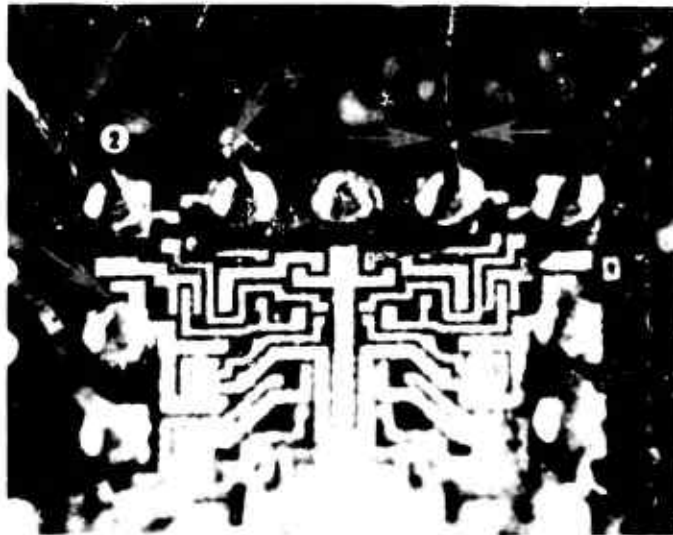
Figure 5-18. Grain Boundary Fracture  
(Lot P3, 30 Cycles of 1010D)

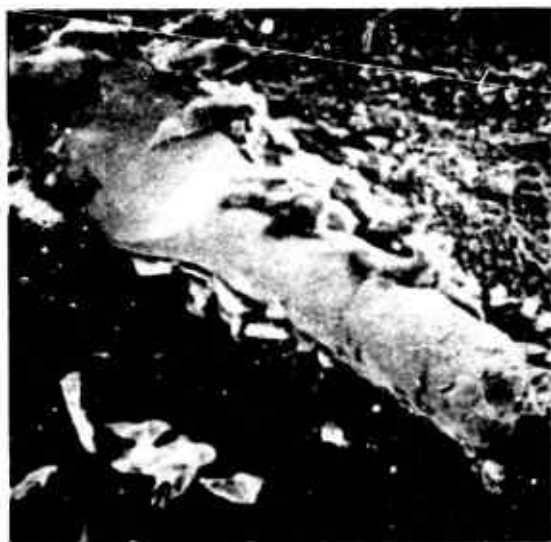
350X

Figure 5-20. Grain Boundry Fracture  
(Lot L1, Epoxy, 500 Cycles of 1010D)

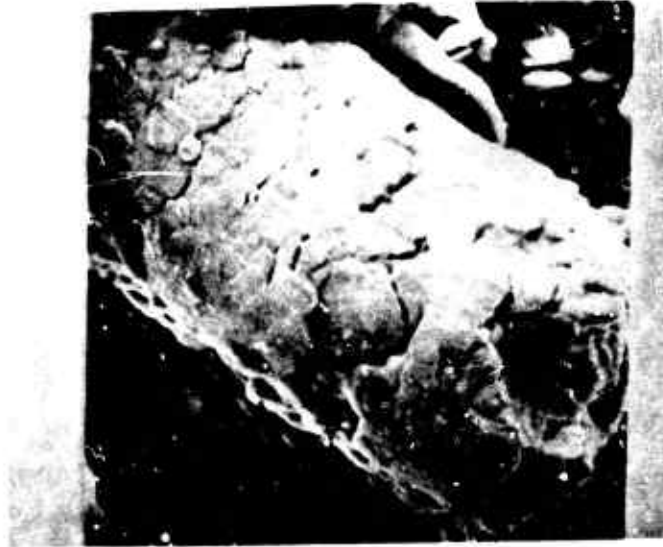
1,000X

Figure 5-21. Grain Boundry Fracture  
(Lot L1, Epoxy, 500 Cycles of 1010D)

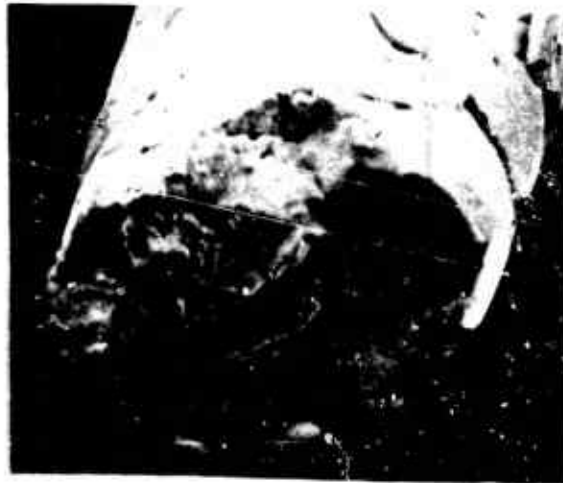
2,000X

Figure 5-22. Grain Boundry Fracture  
(Lot L1, Epoxy, 500 Cycles of 1010D)

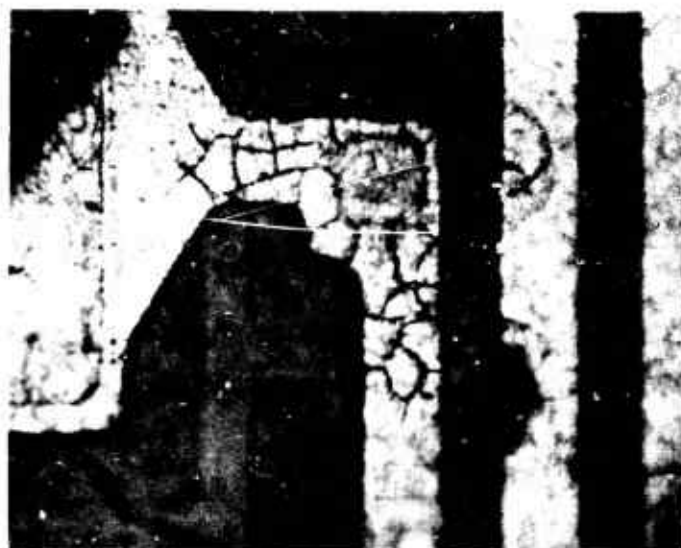
Figure 5-24. Corrosion  
(Lot G4, 3005 Cycles of 1011A)
